**ALABAMA HAZARDOUS WASTES MANAGEMENT AND MINIMIZATION ACT (AHWMMA)**  
**Compliance Evaluation Inspection (CEI) Report**

Parker Hannifin Corporation (Parker)  
1005 A Cleaner Way SW  
Huntsville, (Madison County), Alabama 35805

March 13, 2017

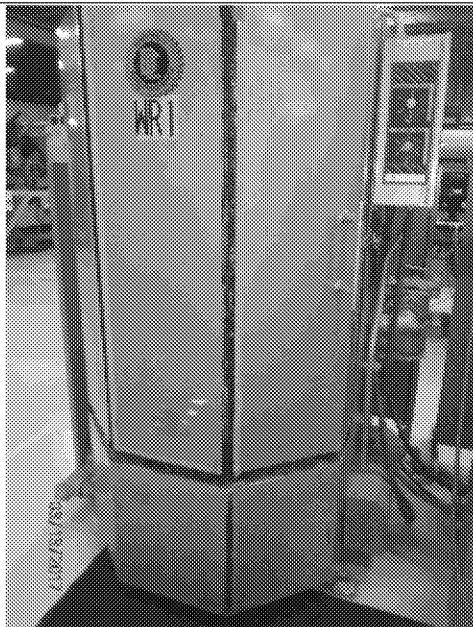
Next, we were escorted through the production area where parts are manufactured. In this area we first observed a Better Engineering URL Parts Washer (see Photograph #1) used to clean various parts before they are processed. According to Mr. Manning, the waste generated in the parts washer is not sent to the on-site wastewater treatment unit. Next to the parts washer, we observed the brass bright dip line and the passivation line (see Photograph #2 and #3). The brass bright dip line is for the appearance of the brass and there is no material added to the products. It produces a shiny end result and removes any minor corrosion that may be present. The line contains a couple of water rinse tanks, a peroxide tank, a soap tank and a caustic tank to produce the desired result. The passivation line is used for the stainless steel products. It contains a tank of citric acid and two water rinse tanks.

Photograph # 1: Production Area – parts washer

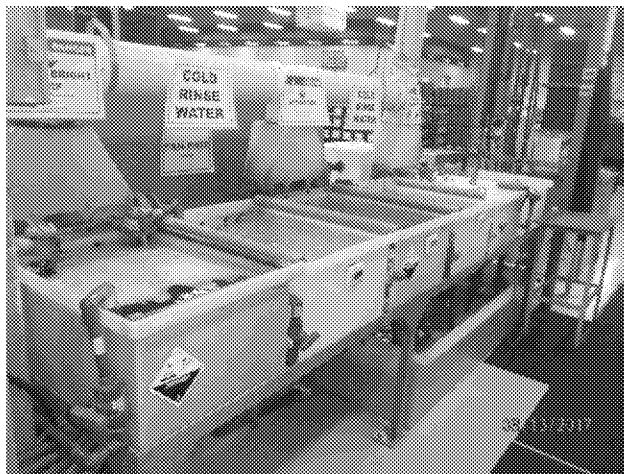
Photograph#2: Production Area – Brass Bright Dip Process

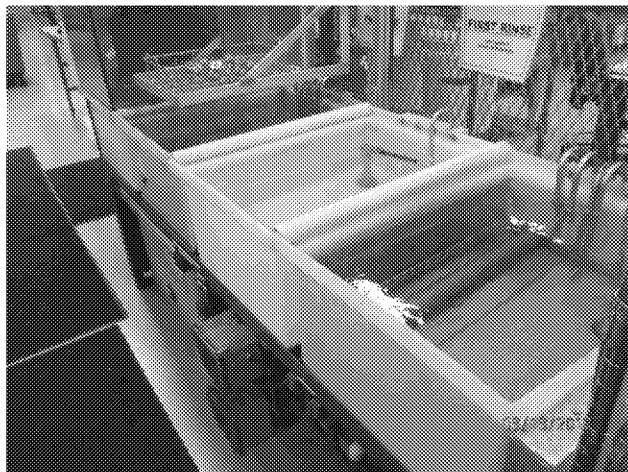
Photograph #3: Production Area – Passivation Line

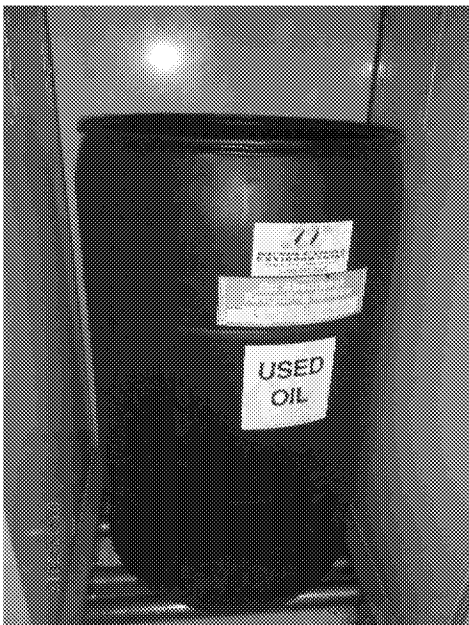
Next, we were escorted to three yellow fireproof metal cabinets that were staged along a wall in the production area. Each cabinet was locked and located inside each cabinet was a 55-gallon drum containing used oil absorbents (see Photograph #4). The drums were all labeled with the words "Used Oil" (see Photograph #5), but none of the drums were closed. All three of the drums were closed at the time of the inspection. In the same area, we observed a one quart container labeled with the words "Used Water & Oil" located underneath a coolant oil skimmer. The container was open at the time of the inspection (see Photograph #6).

Photograph #5: Production Area – used oil absorbent drum

1. Three 55-gallon drums containing used oil absorbent rags were not closed. All of the drums were closed during the inspection;
2. One quart container holding used oil staged underneath a coolant oil skimmer was not closed;

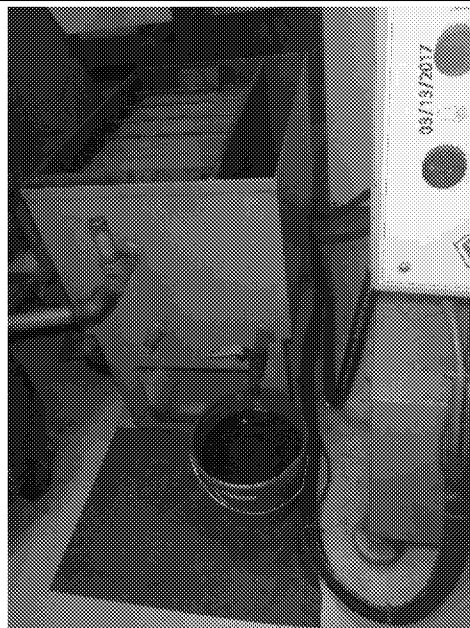
Photograph #6: Production Area – coolant oil skimmer with used oil/water container

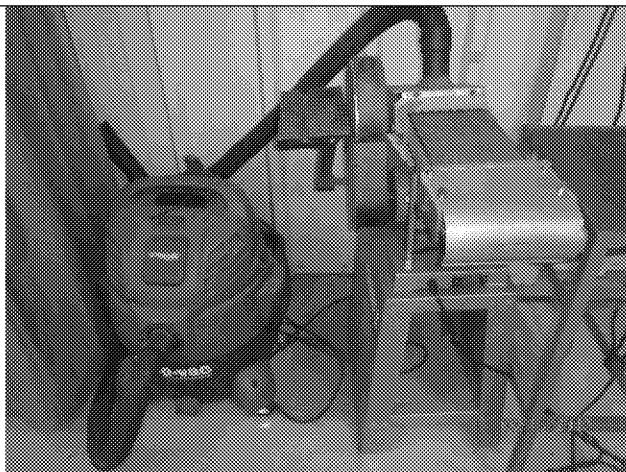
Next, we were escorted to a belt sander station that had a dry vac connected to the sander for collecting metal chips (see Photograph #7). At the time of the inspection, there was a metal dust mixture from the sander on the floor (see Photograph #8). According to Mr. Manning, the metal chips are sent out for recycling and a hazardous waste determination has not been conducted on the metal chips.

Photograph #7: Production Area – dry vac for belt sander

13. No hazardous waste determinations on the red garnet sand and the dry vac containing the mixed metal dust.

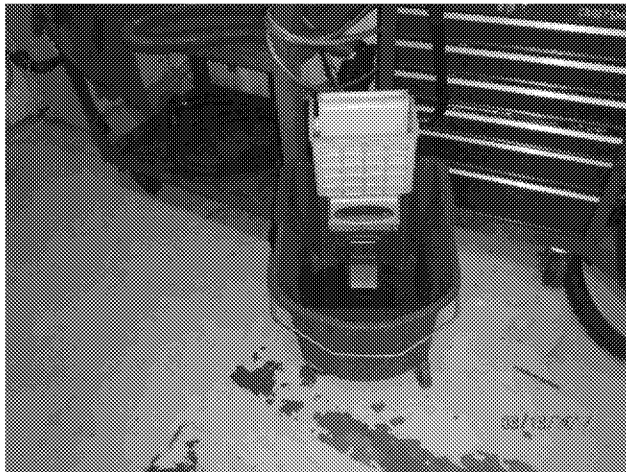
Next, we were escorted to the oil room which is located next to the production area. In this area, we observed a mop machine, mop bucket, and one used oil collection tank. According to Mr. Manning, the mop bucket is used in cleaning areas where the mop machine cannot access. The mop bucket was not labeled with the words "Used Oil" (see Photograph #9). The approximate 70 gallon used oil collection tank was labeled with the words "Used Oil", but not closed (see Photograph #10). The used oil collection tank was closed at the time of the inspection.

Photograph #9: Oil Room – used oil mop bucket

3. One 70 gallon used oil collection tank was not closed. The collection tank was closed during the inspection;
4. Mop bucket used in cleaning used oil was not labeled with the words "Used Oil";

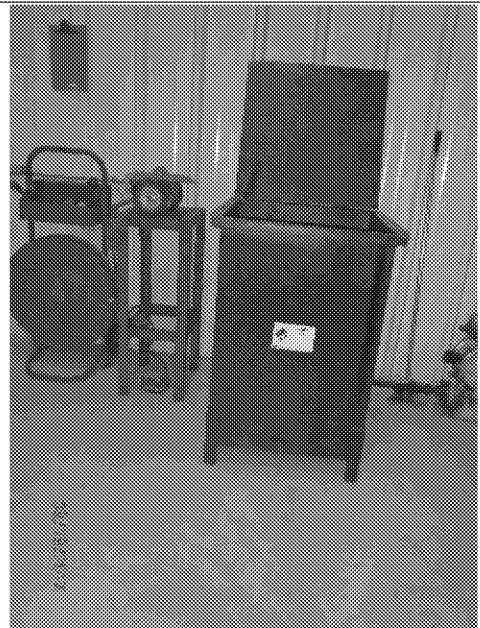
Photograph #10: Oil Room – 70-gallon used oil collection tank

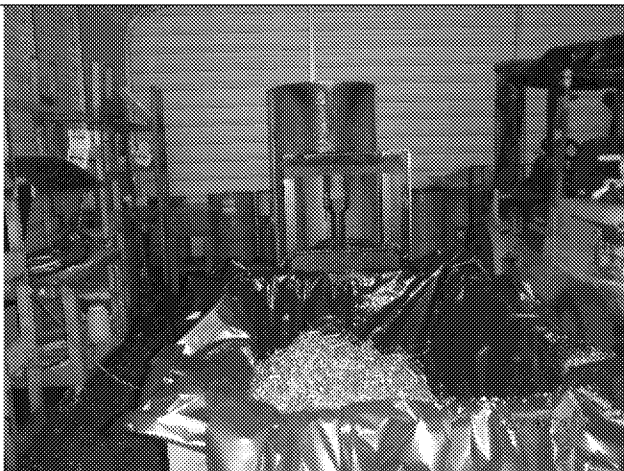
Next, we were escorted outside to the chip processing area that consisted of a metal corrugated shed. Under the shed, metal chips are stored and segregated by material type. The shed also contained several empty drums (see Photograph #11). No areas of concern were noted at the chip processing shed at the time of the inspection.

Photograph #11: Chip Shed

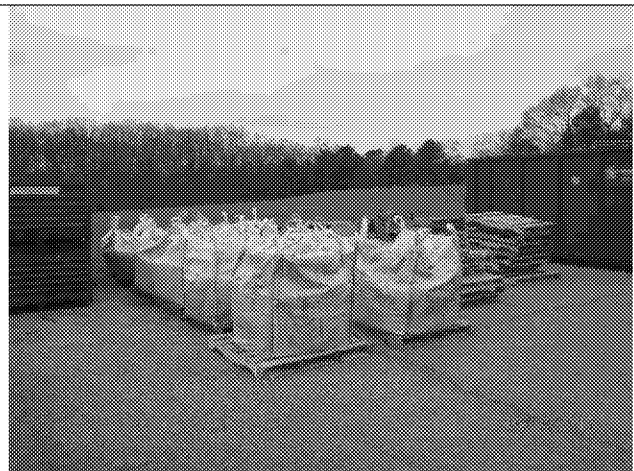
Next, we were escorted to an area outside the facility where the used red garnet sand is stored. In this area, we observed 12 super sacks of used red garnet sand (see Photograph #12). According to Mr. Manning, the sand is non-hazardous, but is picked up by a hazardous waste transporter. A hazardous waste determination has not been determined on the sand.

Photograph #12: Used red garnet sand for disposal

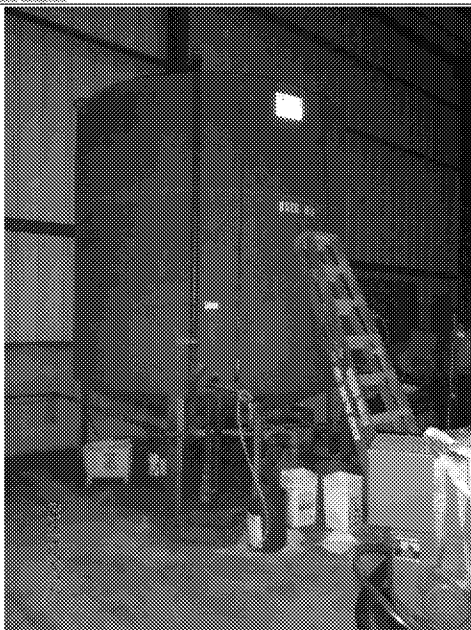
processing shed. In this area, we observed a 10,000 gallon used oil storage tank (see Photograph #13). The tank was equipped with a secondary containment system and labeled with the words "Used Oil". Next to the used oil storage tank we observed three 5-gallon containers and one small pan containing used oil (see Photograph #14 and #15). The containers were open and not labeled with the words "Used Oil".

Photograph #13: Oil Shed – Used Oil Tank

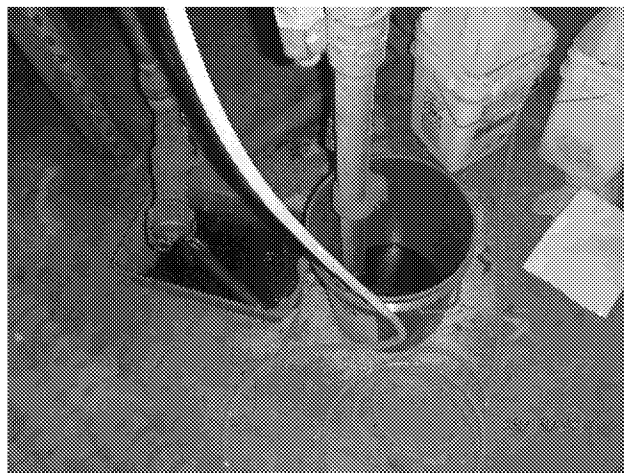
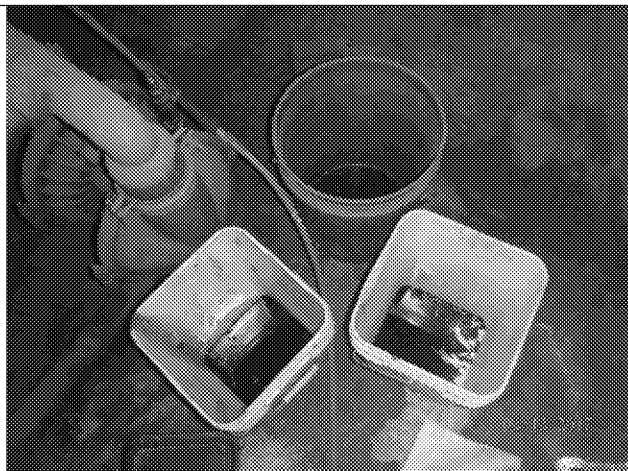
Photograph #14: Oil Shed – Used, open, and unlabeled oil containers

Photograph #15: Oil Shed – Used, open, and unlabeled oil containers

5. Three 5-gallon containers and one small pan staged in the Oil Shed containing used oil were not closed or labeled with the words "Used Oil";
6. Seven boxes of 4ft used fluorescents lamps and one 8ft box of used fluorescent lamps were open;

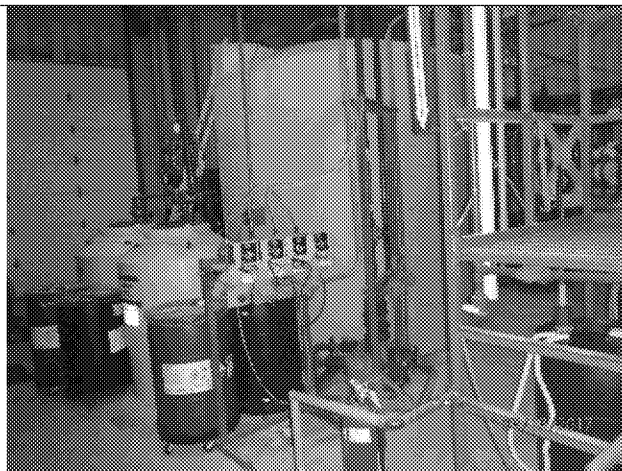
Next, we were escorted to the wastewater treatment unit area (see Photograph #16). The wastewater treatment unit is a microfiltration unit and is only in operation once or twice a week due to the low flow of material coming in. The main use of the unit is for minor pH adjustments. In this area, we observed the hazardous waste sludge press with a fiber board container underneath the press covered in plastic (see Photograph #17). According to Mr. Manning, the container was covered with the plastic due to the room being hosed down and cleaned once a month. Underneath the plastic, the container was labeled with the words "Hazardous Waste", "F006 Metal Hydroxide", and dated "2/3/17". According to daily logs that Mr. Manning keeps, the sludge dryer was emptied on "2/3/17".

Photograph #16: Wastewater Treatment Area

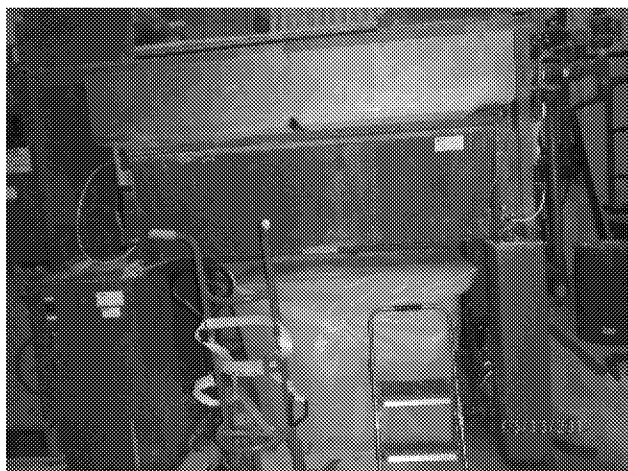
Photograph #17: Wastewater Treatment Area – hazardous waste sludge press and fiber board container

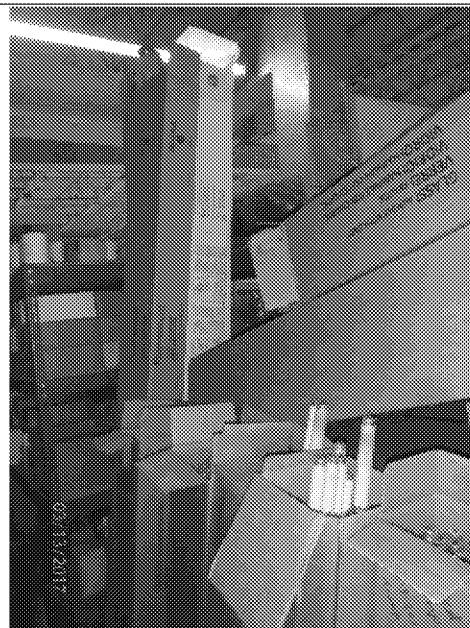
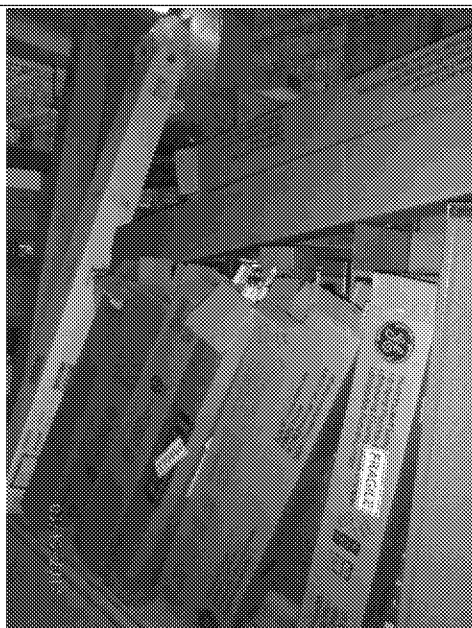
Next, we were escorted to the mezzanine where the universal waste is stored. In this area, we observed seven 4ft cardboard boxes of spent fluorescent lamps and one 8ft cardboard box of spent fluorescent lamps. Three of the boxes were not marked with accumulation start dates, two of the boxes were not labeled with the words "Universal Waste", and all of the containers were open (see Photograph #18 and #19).

Photograph #18: Universal waste lamp storage

Photograph #19: Universal waste lamp storage

7. Three boxes of used fluorescent lamps were not marked with an accumulation start date and two boxes of used fluorescent lamps were not labeled;
8. One half gallon container of NiCd batteries dated "12/14/15" and one 3.5 gallon container of lithium ion batteries dated "10/6/15" were stored longer than the allowed year;

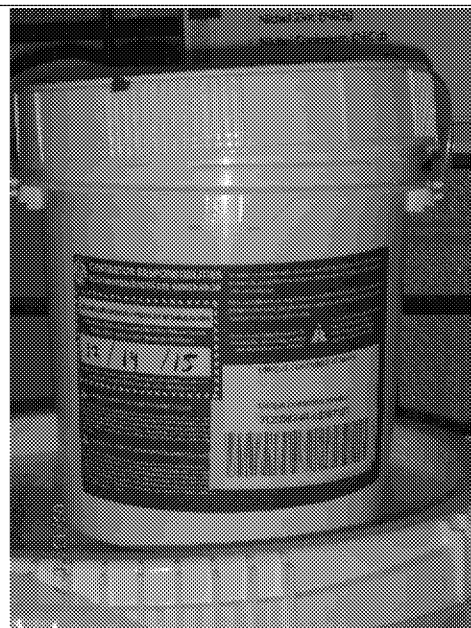
Last, we were escorted to the universal waste storage for batteries. In this area, we observed a ½ gallon container of NiCd batteries that were open and marked with an accumulation start date of "12/14/15" (see Photograph #20), a ½ gallon container of Nickel Metal Hydride batteries that were closed and marked with an accumulation start date of "4/20/16" (see Photograph #21), and a 3.5 gallon container of Lithium Ion batteries that were closed and marked with an accumulation start date of "10/6/15" (see Photograph #22). All of the containers were labeled with the words "Hazardous Waste".

Photograph #20: Universal waste nickel cadmium batteries

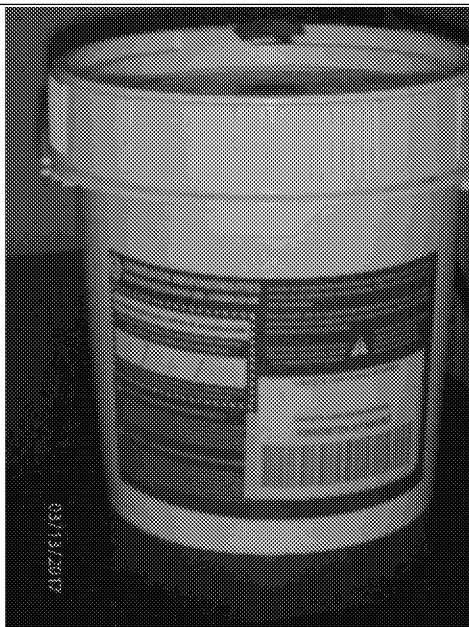
Photograph #21: Universal waste nickel metal hydride batteries

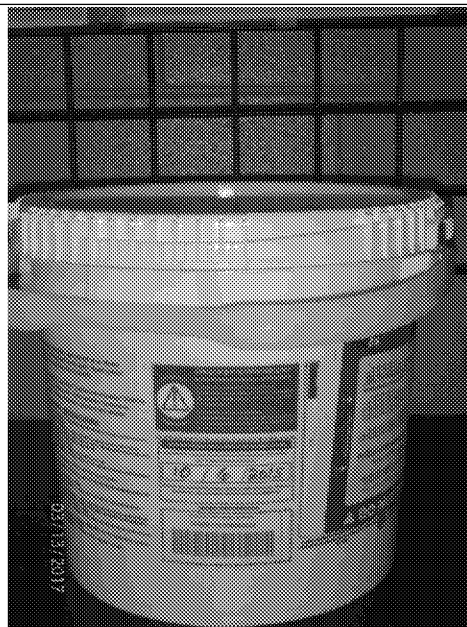
Photograph #22: Universal waste lithium ion batteries
